Annual Inspection

Winchester City Council

Recreation Ground (Cheriton PC)

Westfield Road, Cheriton, Arlesford, Hampshire, SO24
0QH

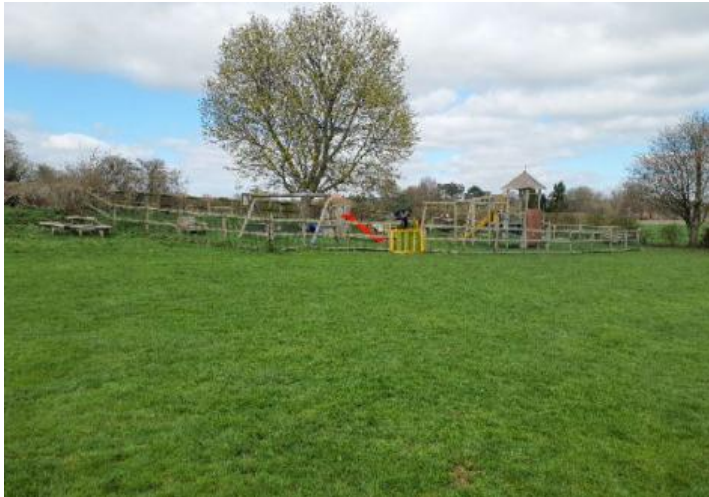
Finding: It is recommended that signage, with information including the site address, contact information for maintenance issues and emergency contact details are provided for the facility

Action: Provide in accordance with the recommendations

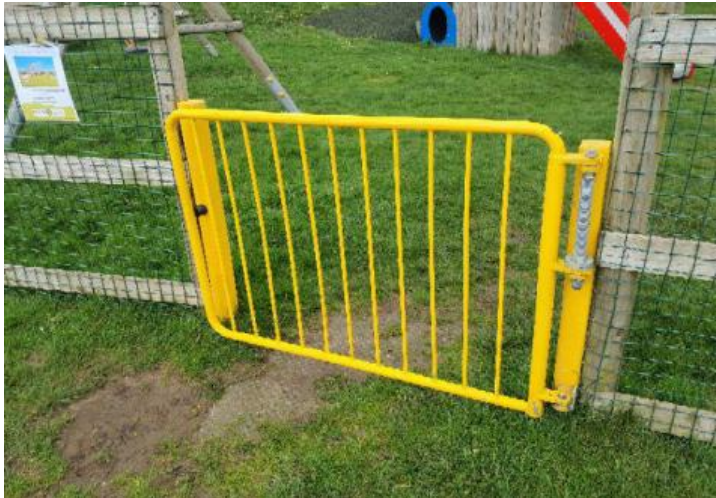
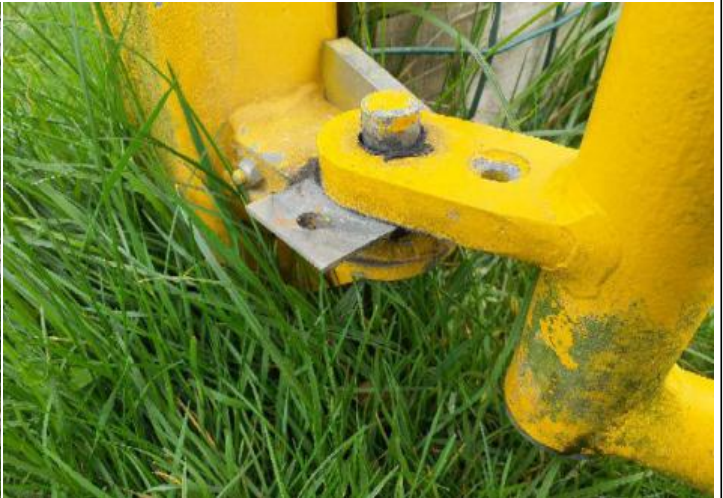
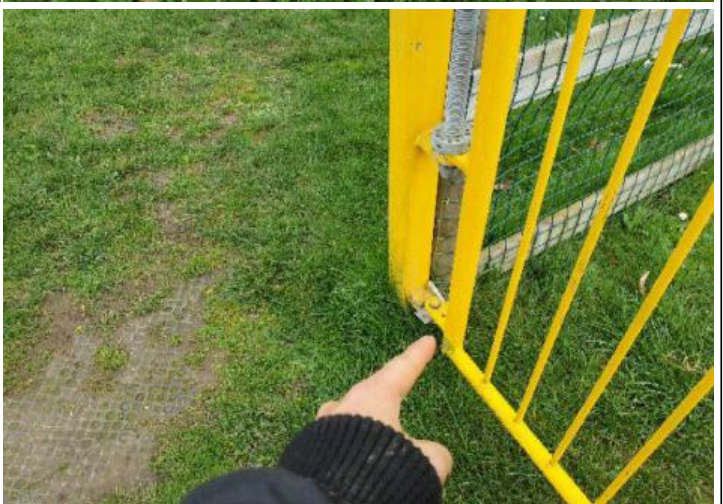
Finding: There is a missing fixing and a bracket has slipped out of place with sharp edges **Action:** Repair

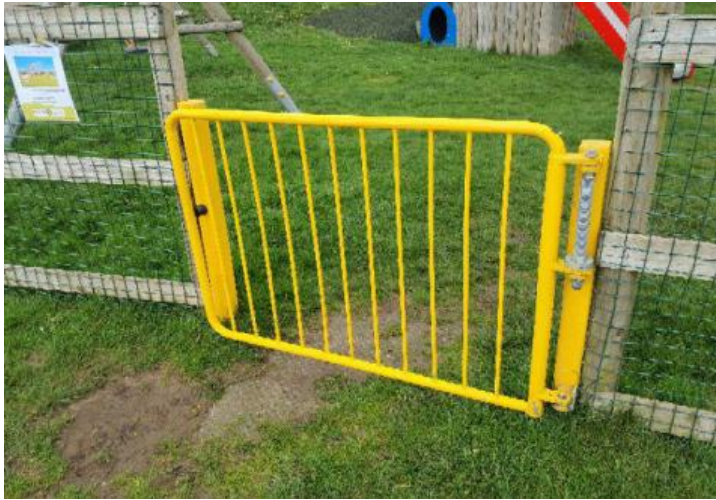
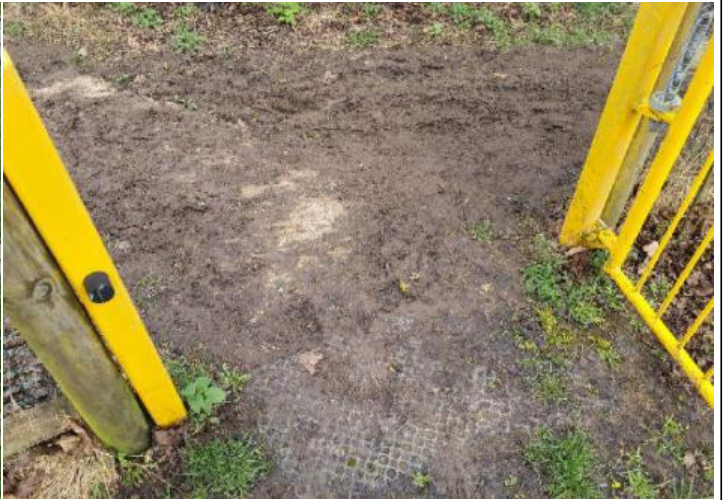
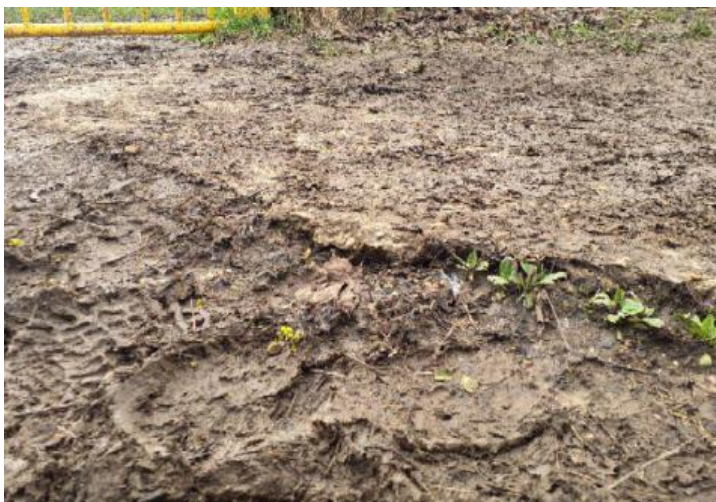
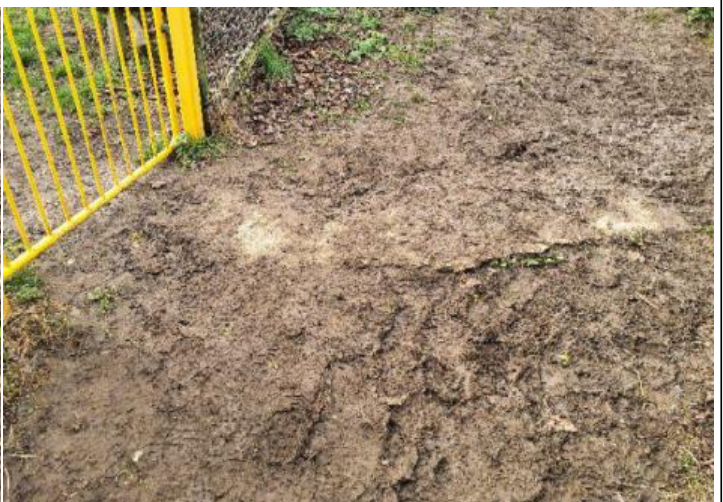
Finding: The area under the gate has eroded leaving uneven areas, or the concrete foundations exposed, resulting in trip hazards at the entrance/exit to the playground

Action: Reinststate to level with surrounding surfaces

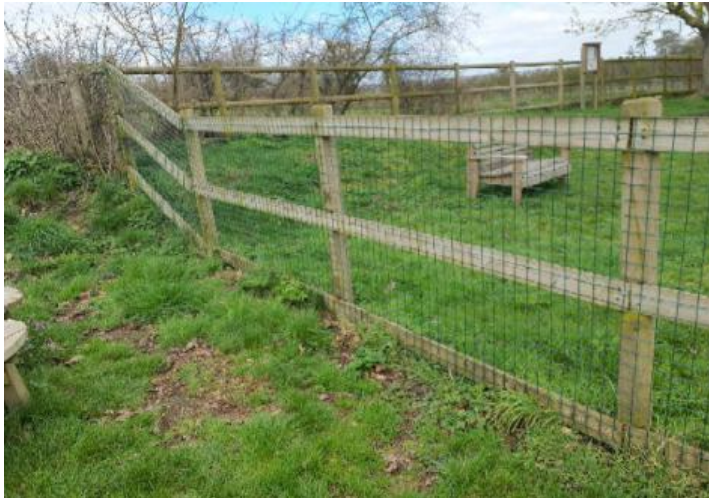
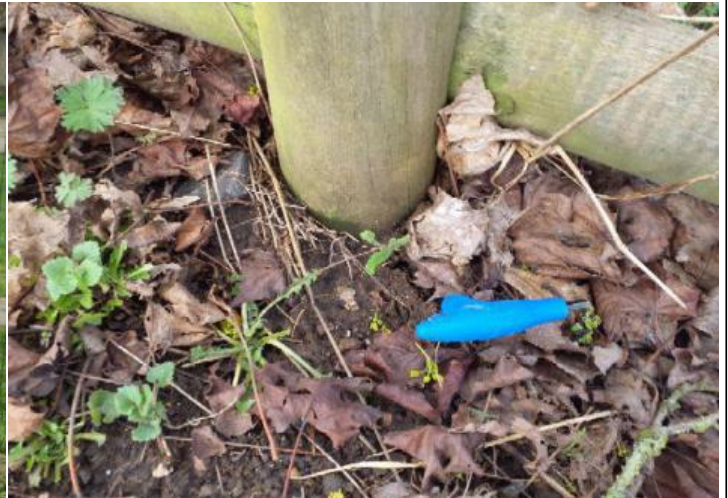
Finding: There is some evidence of rot in the timber

Action: Monitor for any further deterioration and replace as required

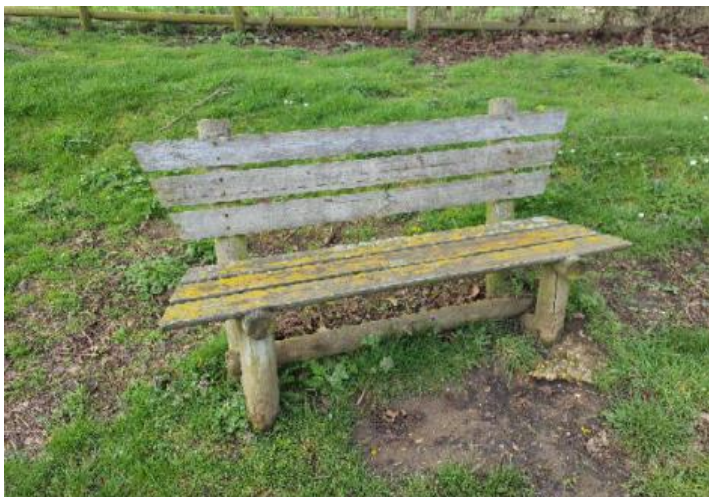
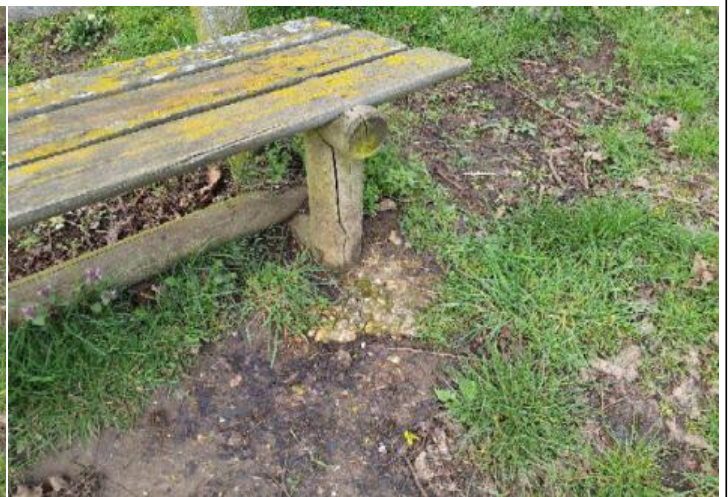
Finding: The foundations are exposed

Action: Reinstate surrounding surfaces to cover the foundations

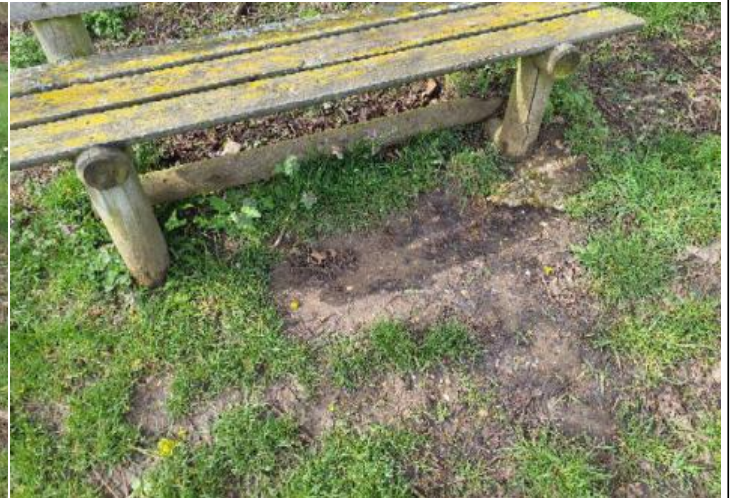
Finding: The area around the item has eroded and may become slippery

Action: Reinstatate eroded area

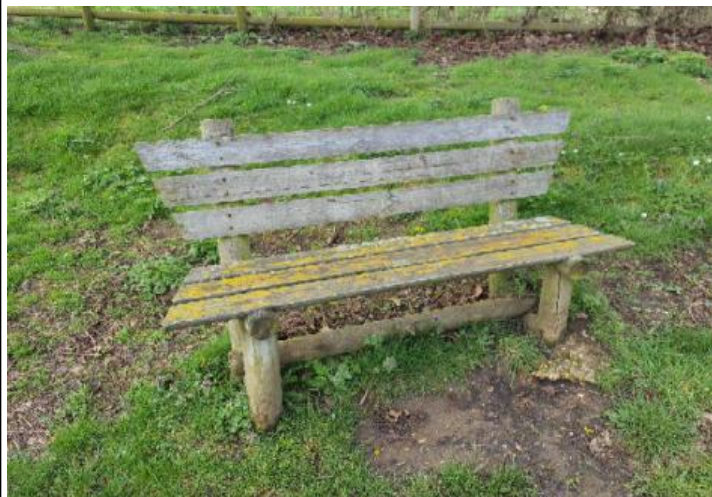
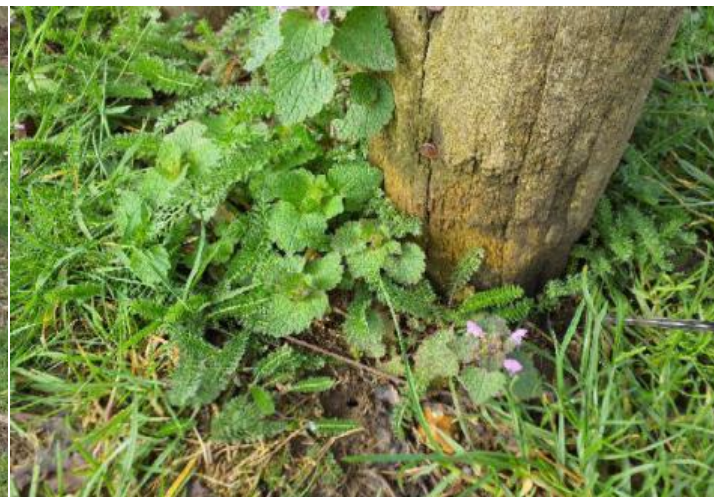
Finding: There is some strimmer / machinery damage apparent on the posts, this can penetrate the preservative applied to the timber and accelerate the rotting process

Action: Monitor for any deterioration (rot) and replace as required

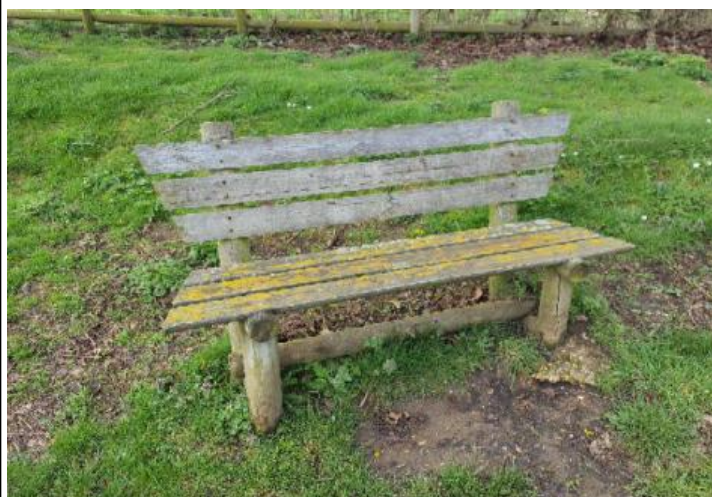
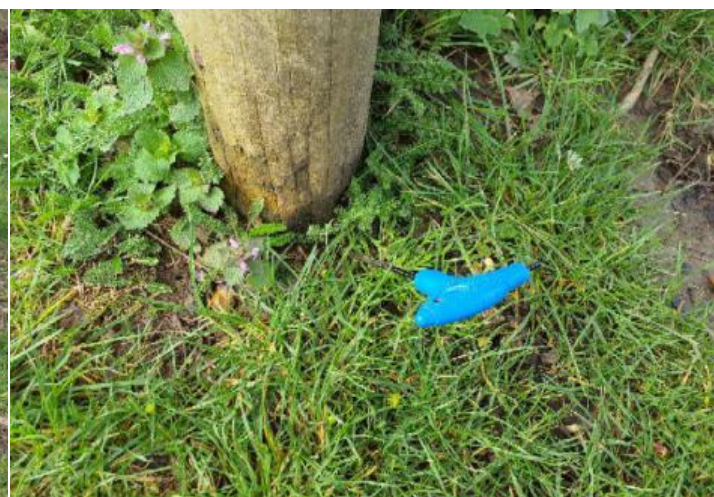
Finding: There is some evidence of rot in the timber

Action: Monitor for any further deterioration and replace as required

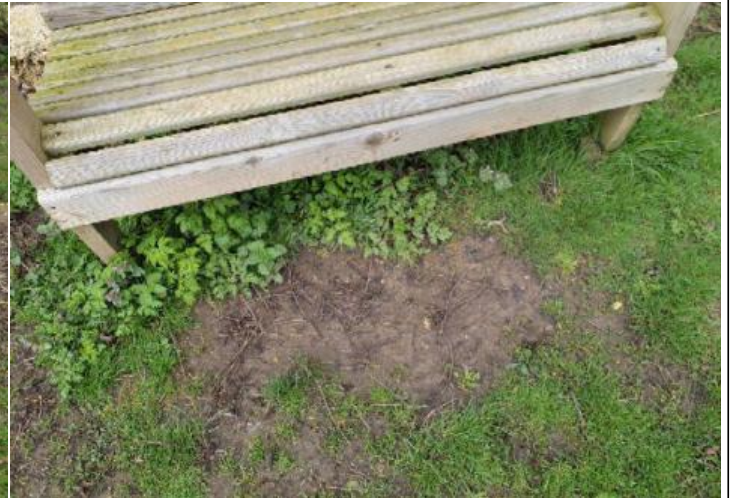
Finding: The area around the item has eroded and may become slippery

Action: Reinstate eroded area

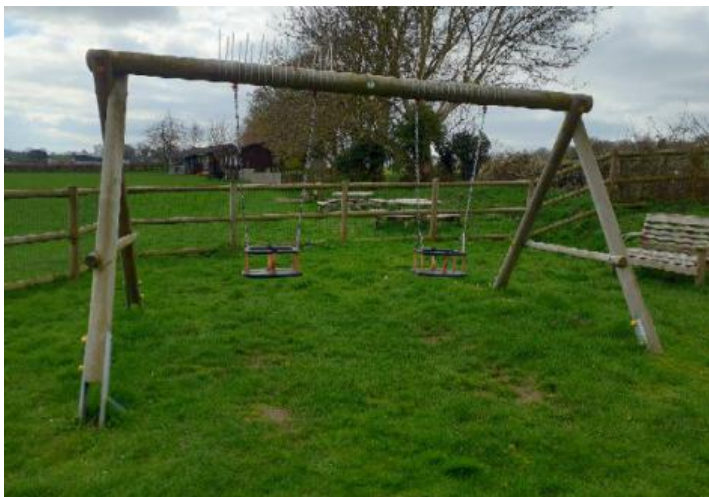
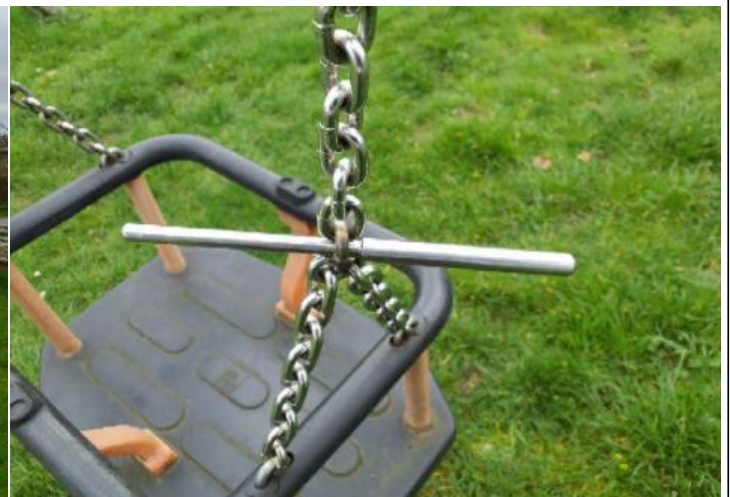
Finding: The chain openings are in excess of the 8.6mm as recommended by BS EN 1176

Action: Monitor - No remedial work recommended

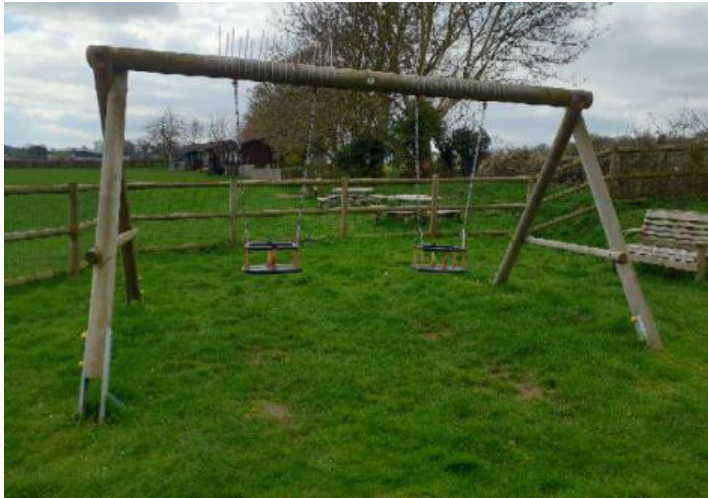
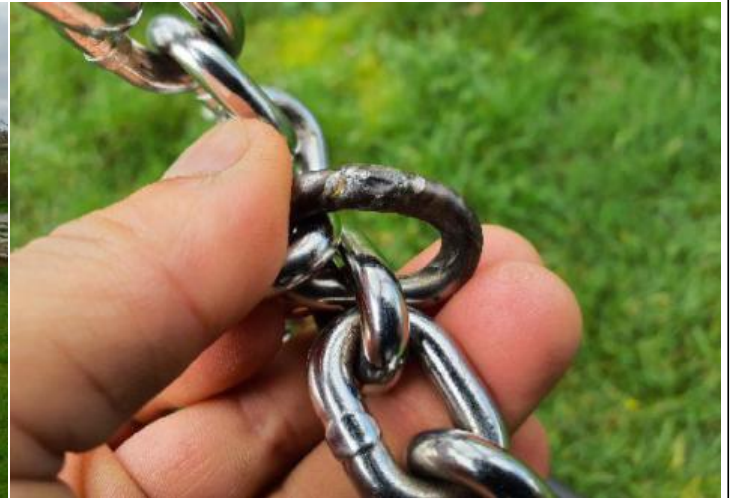
Finding: There is some notable evidence of chain wear

Action: Monitor for any further deterioration and replace when 40% worn

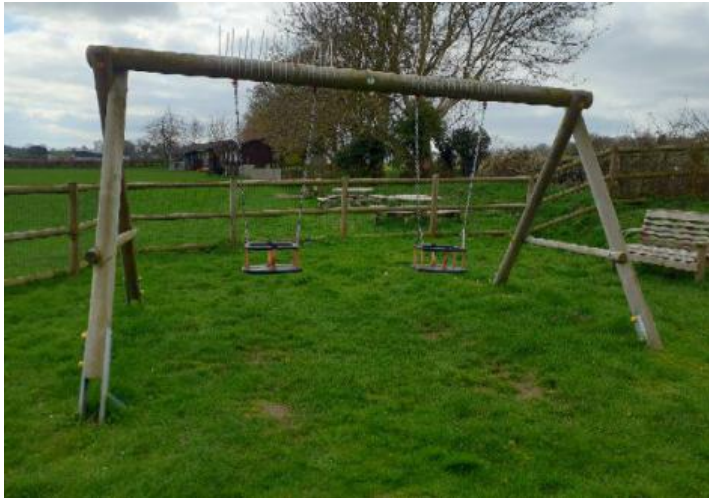
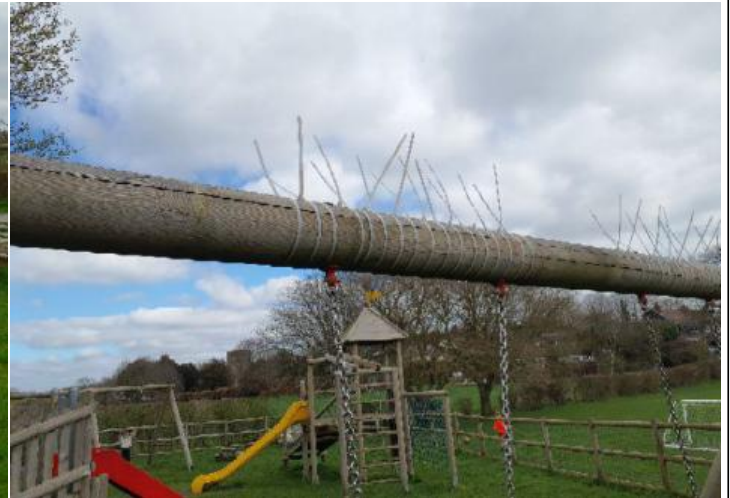
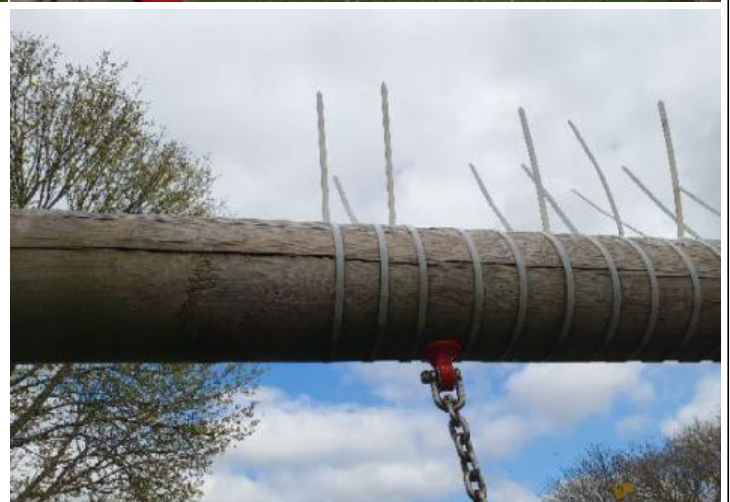
Finding: The timber has a number of splits/shakes or air cracks and this may affect the stability or allow water ingress which will accelerate the rotting process

Action: Monitor to ensure the splits do not cross through fixing points of the structure and/or cause any instability

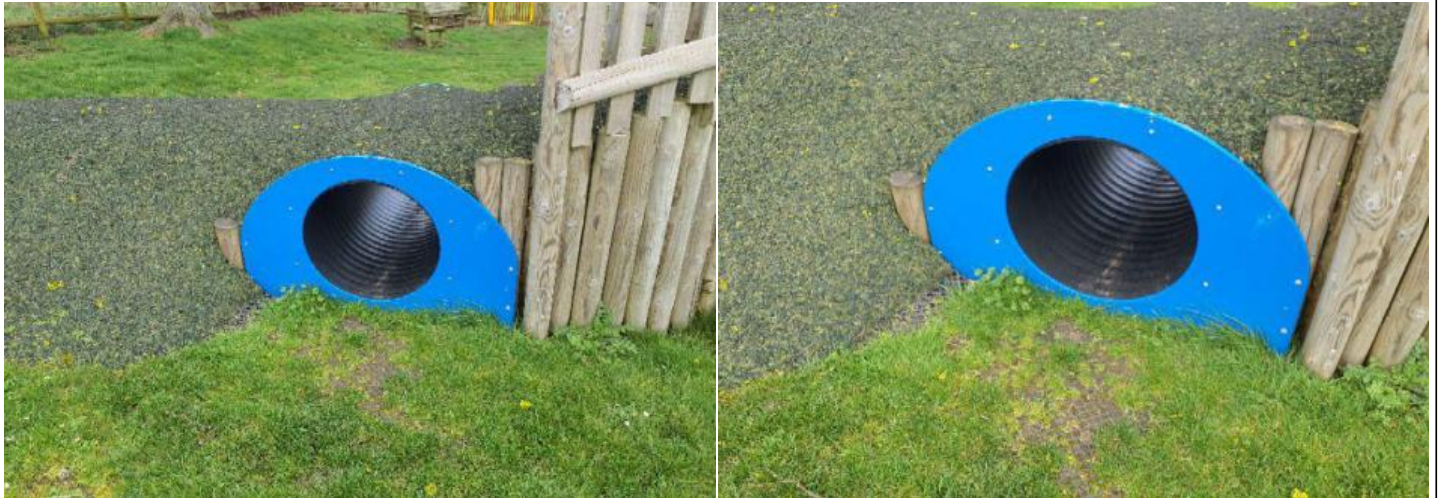
Finding: This design / configuration of tunnel mound is well established and has been successfully included in large quantities of playgrounds throughout the UK. Whilst the design does not fully meet the requirements of BS EN 1176 with regards to falls in excess of 600mm over the edge of the tunnel to the surface below, it has been risk assessed as fit for purpose and no changes are recommended to the design

Action: Monitor - No remedial work recommended

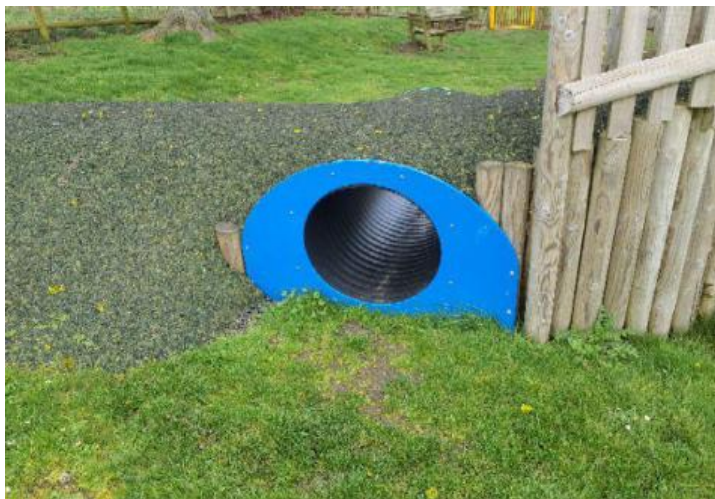
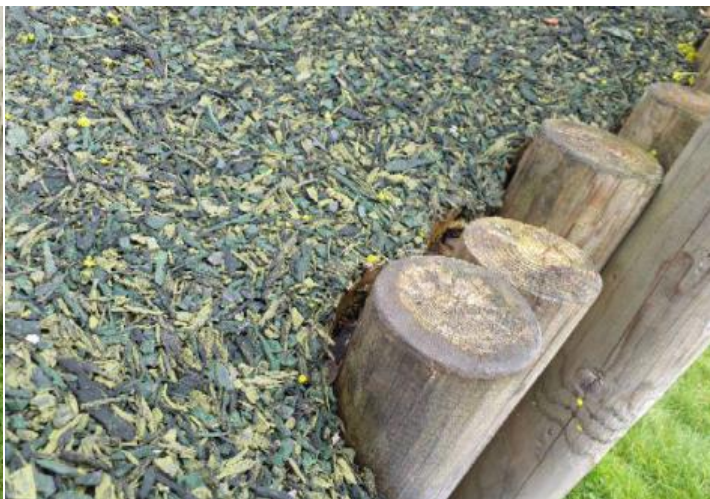
Finding: There are significant gaps (over 30mm) between the surface and the edging or between the joints in the surface; these are large enough for a small foot to enter

Action: Repair surfacing

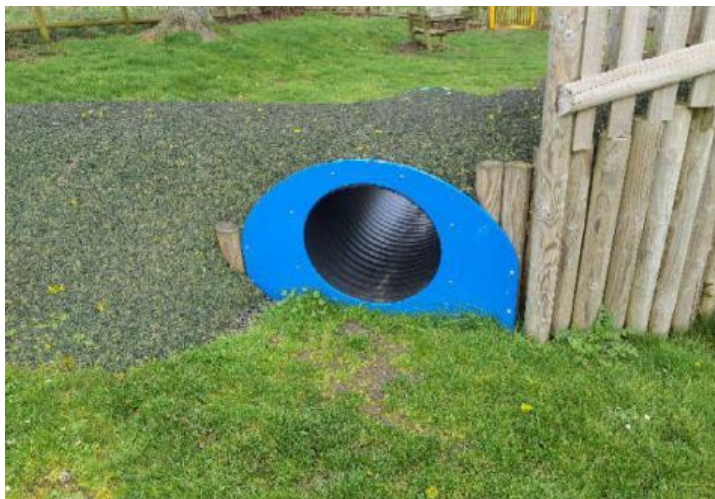
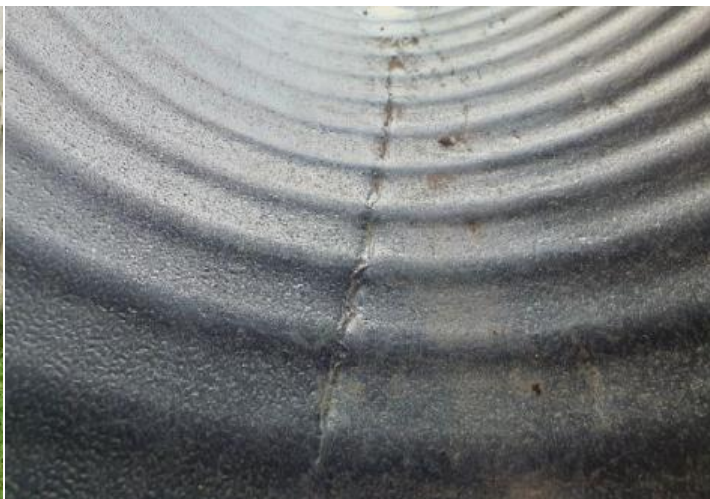
Finding: There is some damage to the item

Action: Monitor for any further deterioration and repair as required

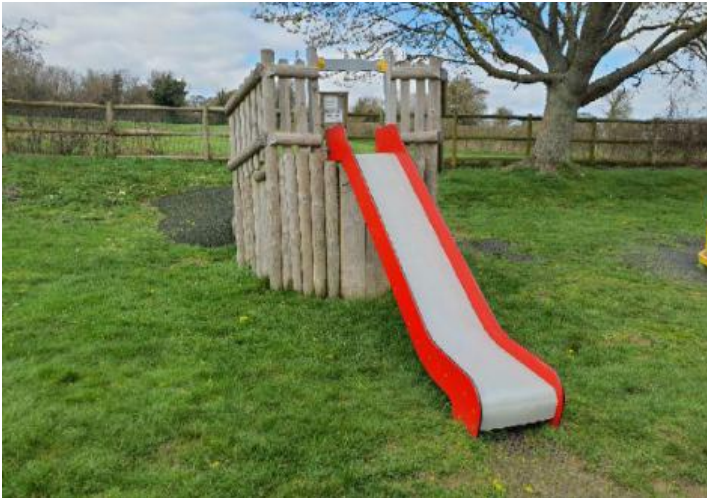
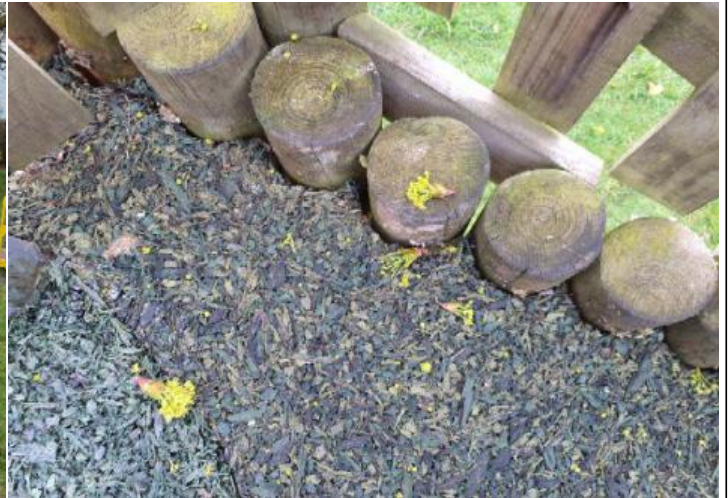
Finding: There are gaps opening between the surfacing and the edging surround or between the joints in the surfacing
Action: Monitor for any further deterioration and repair as required

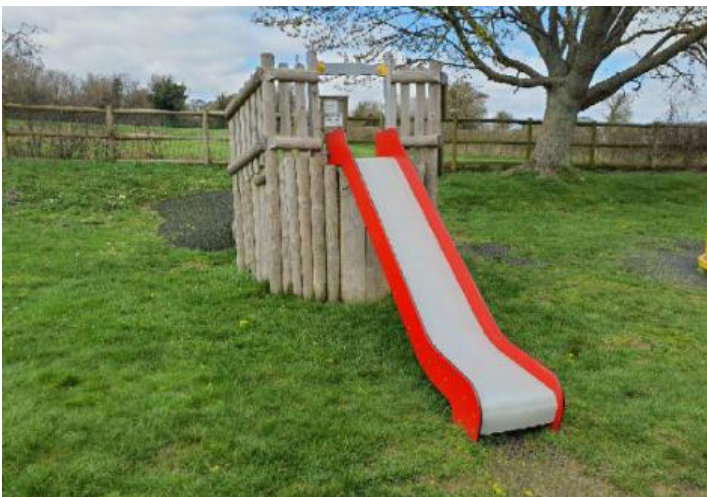
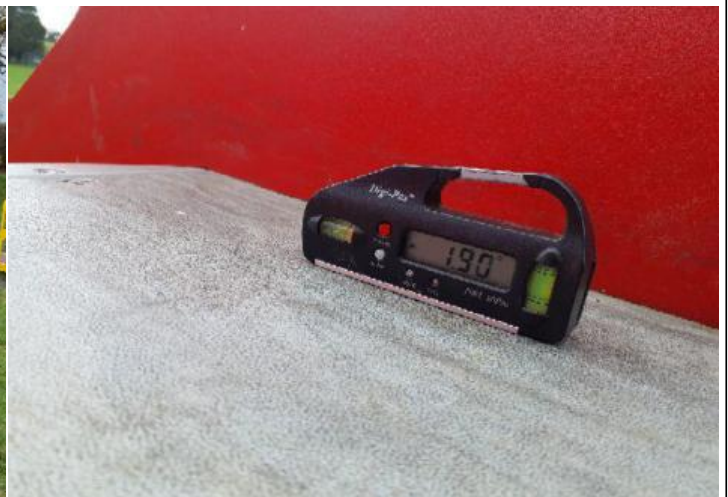
Finding: The slide start section incline is not in the direction of travel; it should slope towards the direction of the sliding surface to meet the requirements of BS EN 1176 Part 3
Action: Monitor - No remedial work recommended

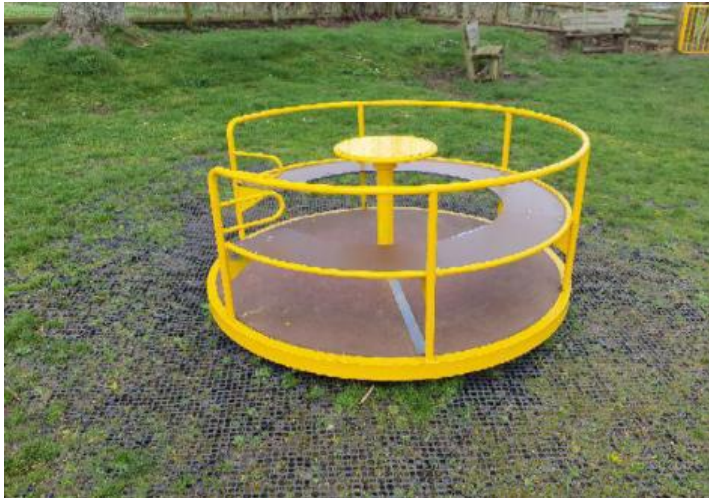
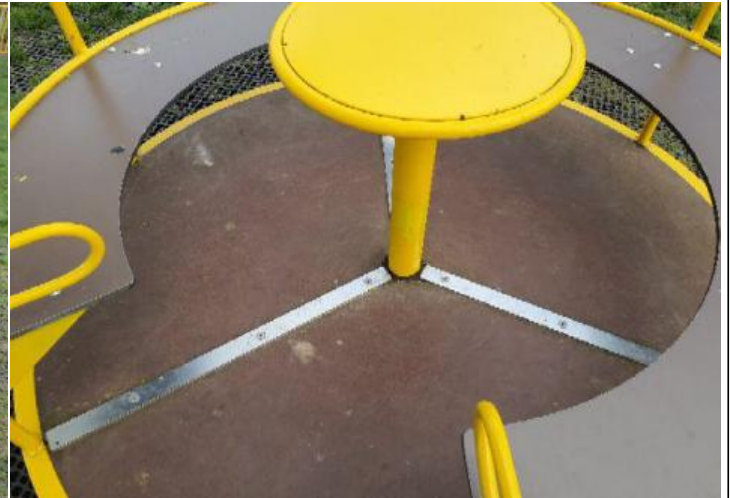
Finding: The bearing is showing signs of wear

Action: Monitor for any further deterioration and replace as required

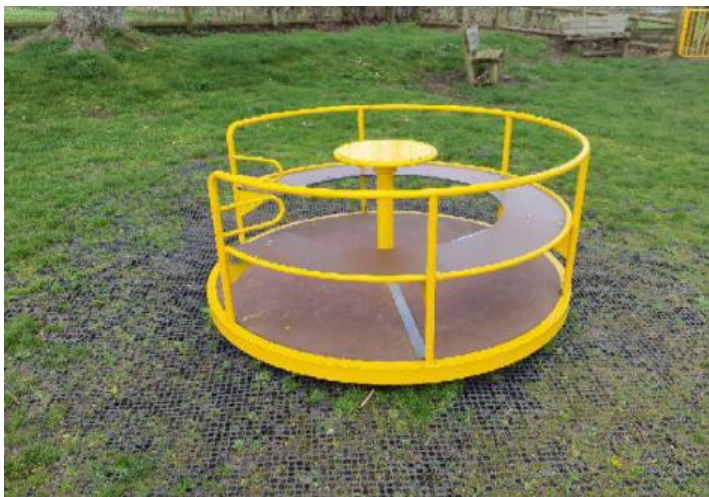
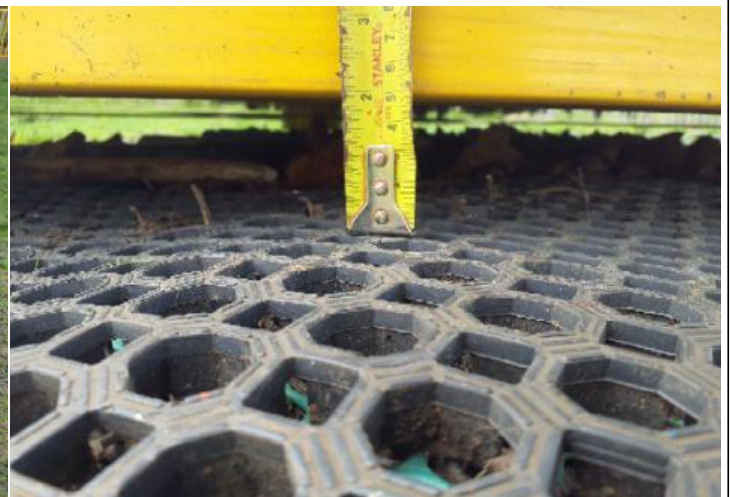
Finding: The distance between the underside of the roundabout platform and the playing surface is less than 60mm and contravenes the requirements of BS EN 1176 Part 5 which requires that the distance be maintained between 60mm-110mm for the entire circumference of the roundabout

Action: Monitor - No remedial work recommended

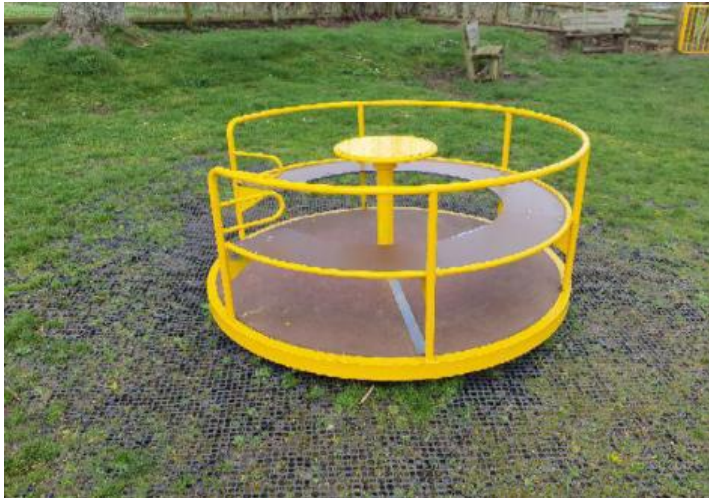
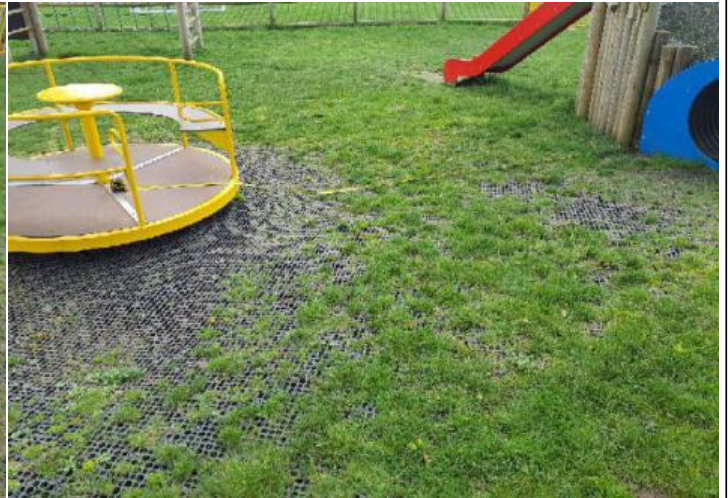
Finding: The falling space overlaps the free space between the roundabout and the tunnel mound / embankment slide in contravention of the requirements of BS EN 1176:2017 Part 1

Action: Monitor - No remedial work recommended

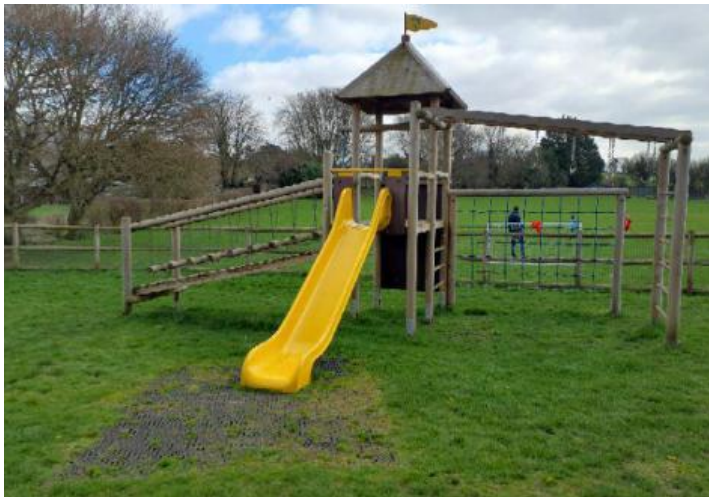
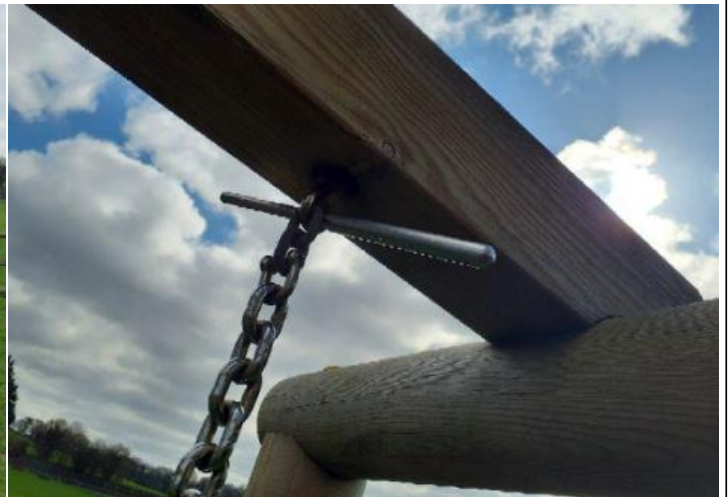
Finding: The connecting links are in excess of 8.6mm and less than 12mm and fail the requirements of BS EN 1176 Part 1; clause 4.2.13, Chains

Action: Monitor - No remedial work recommended

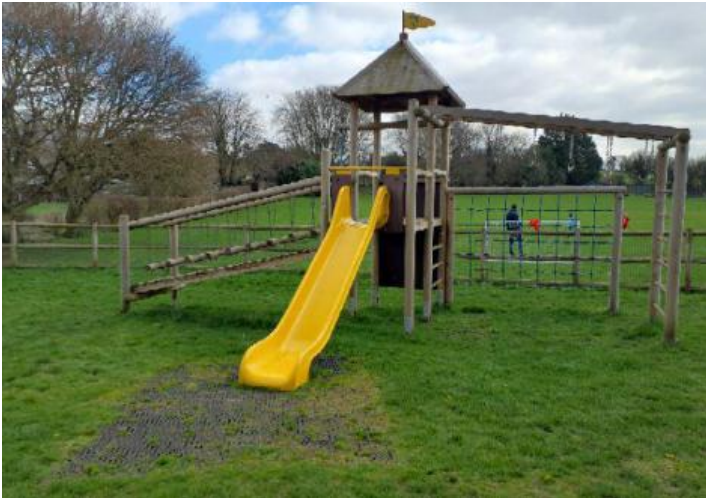
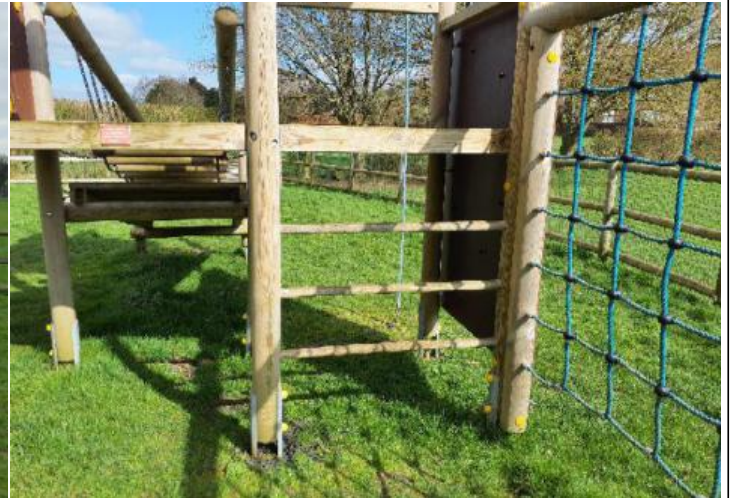
Finding: There are openings leading from platforms in excess of 1.0m in height to steep play elements and no hand supports complying with grip or grasp are provided, in contravention of BS EN 1176 Part 1: 4.2.9.4

Action: Monitor - No remedial work recommended

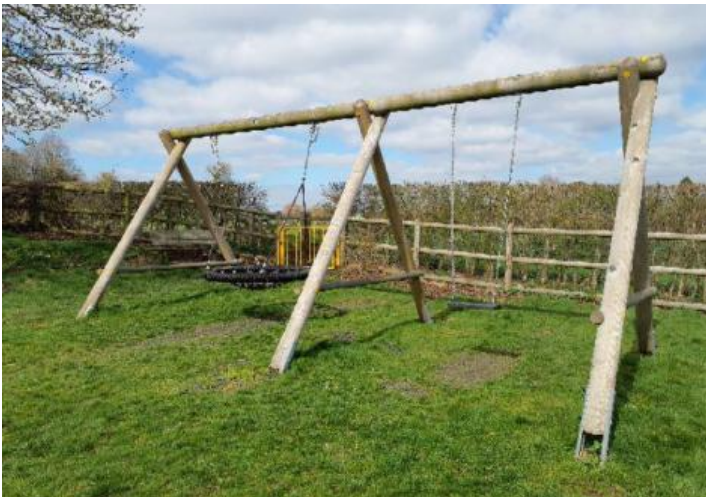
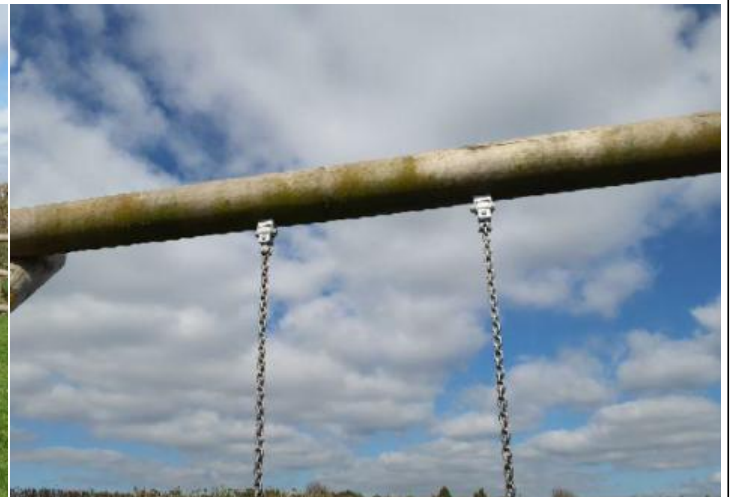
Finding: This design of swing joint has been known to fail on the weld connecting the joint to the threaded stud

Action: We would recommend that the joint be dismantled and checked on a regular basis or consulting with manufacturer on whether a Secondary Safety Device can be fitted

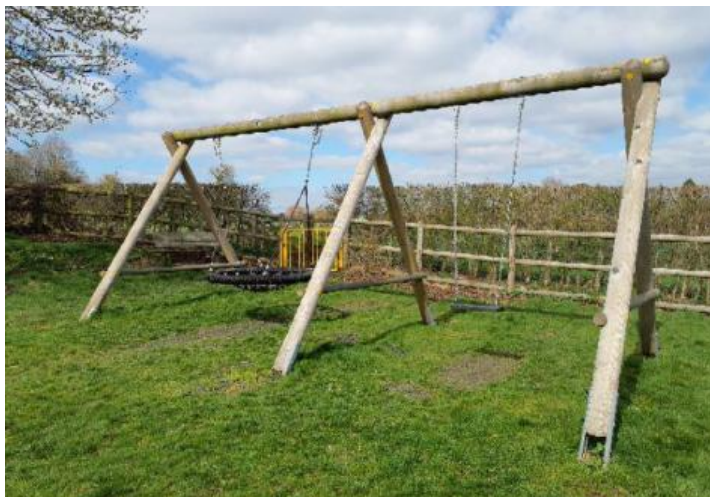
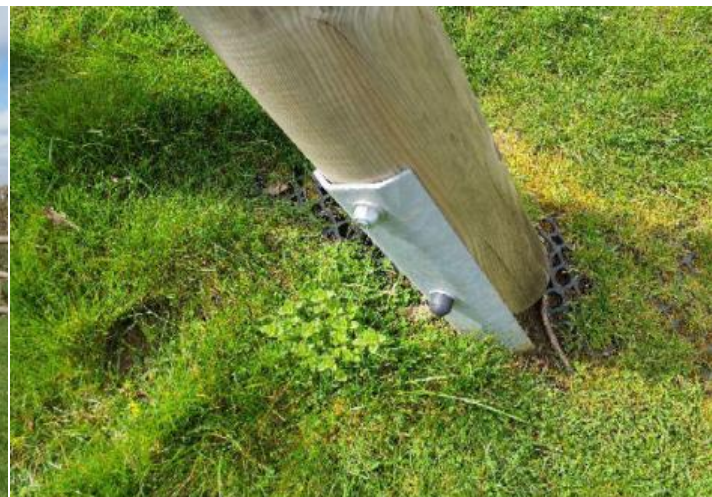
Finding: There is/are bolt cap covers missing or damaged on the item

Action: Replace missing or damaged bolt cap covers

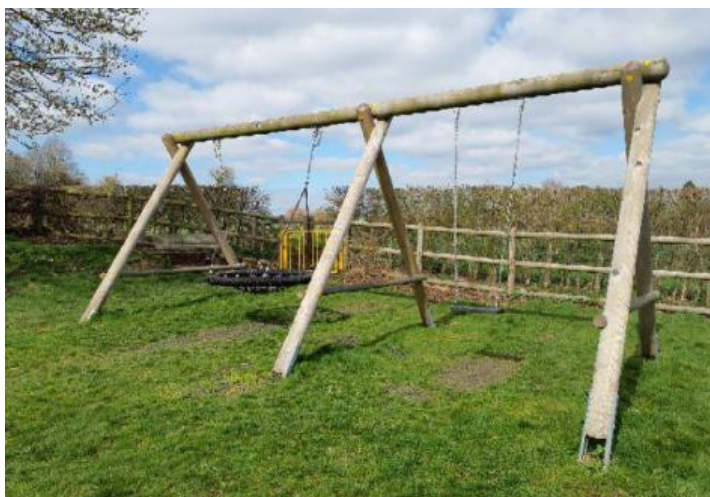
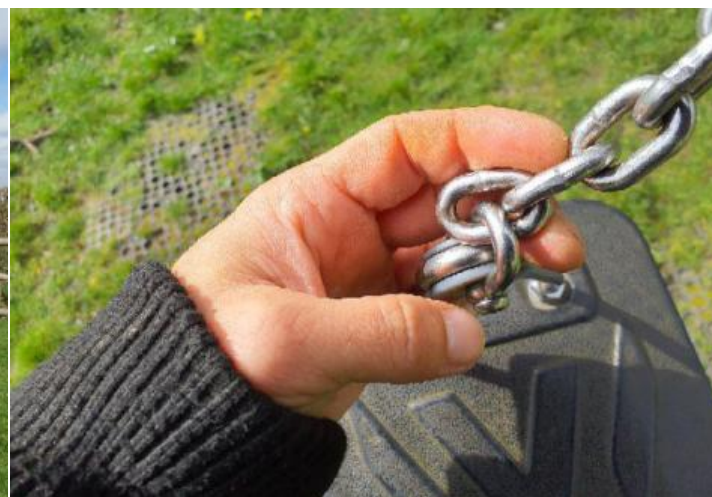
Finding: There is some notable evidence of chain wear

Action: Monitor for any further deterioration and replace when 40% worn

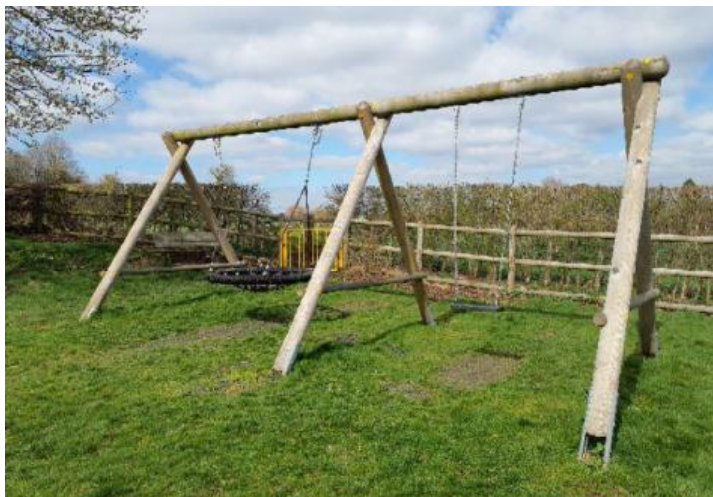
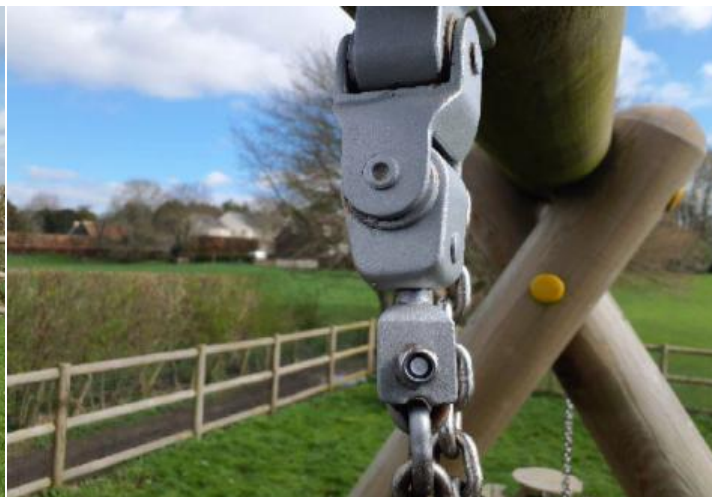
Finding: The swivel joint is worn and requires replacement **Action:** Replace

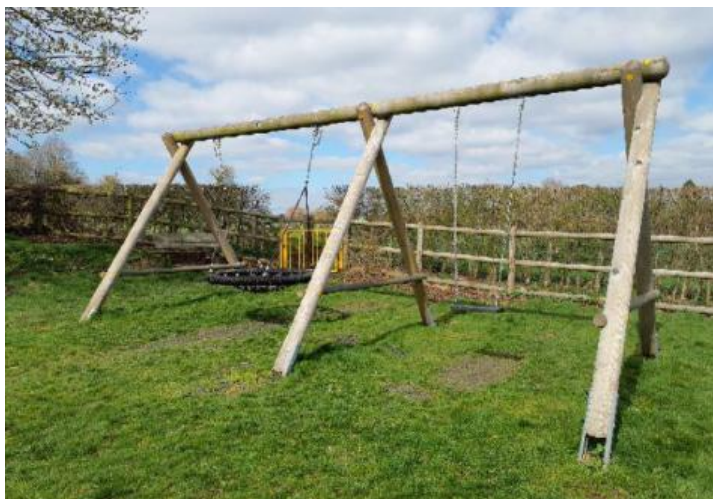
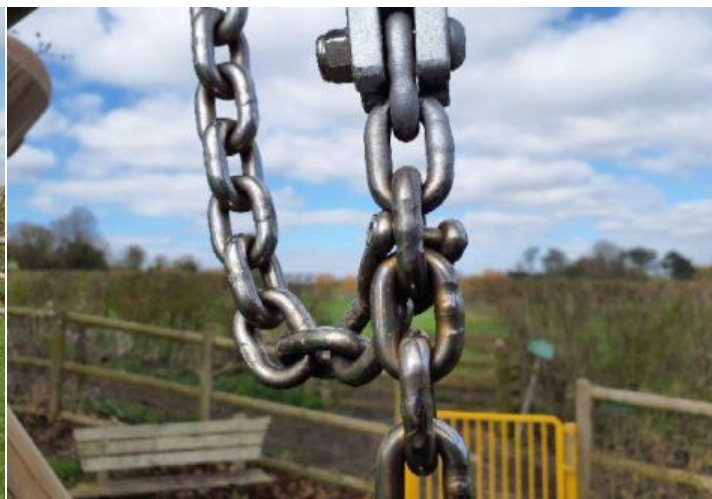
Finding: There is some notable evidence of chain wear **Action:** Monitor for any further deterioration and replace when 40% worn

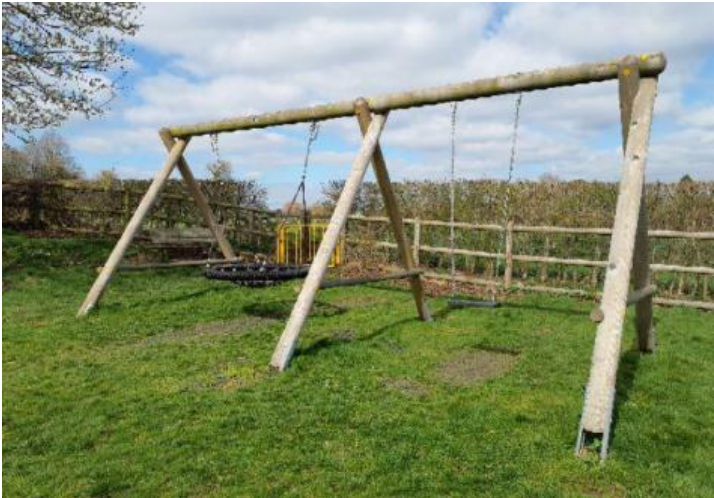
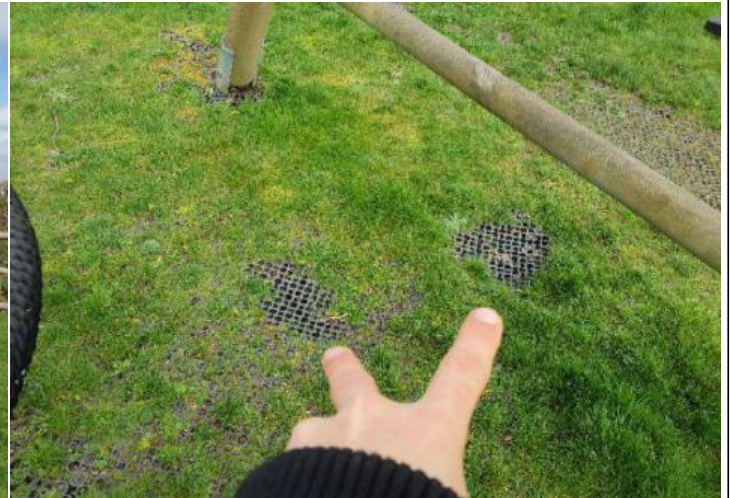
Finding: The surface has subsided in some areas

Action: Monitor for any further deterioration and repair as required
