Annual Inspection

Winchester City Council

Recreation Ground (Cheriton PC)

Westfield Road, Cheriton, Arlesford, Hampshire, SO24
0QH

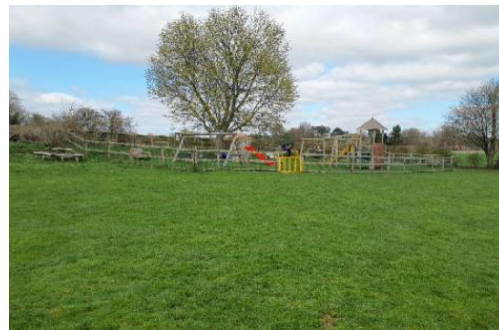
Item: Site General
Manufacturer: Owner/Operator
Surface Type: N/A
Item Quantity: 1
Equipment Compliance: N/A
Surface Area Compliance: N/A

It is recommended that signage, with information including the site address, contact information for maintenance issues and emergency contact details are provided for the facility - Provide in accordance with the recommendations

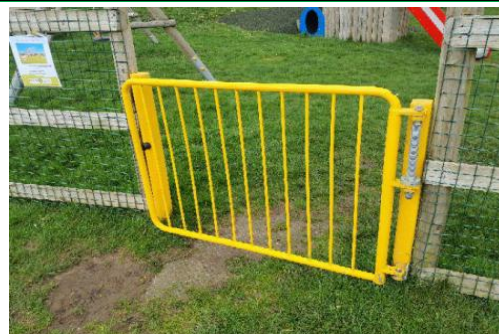
Item: Gate - Self Closing
Manufacturer: I.A.E. Fencing
Surface Type: Grass Matrix Tiles
Item Quantity: 2
Equipment Compliance: N/A
Surface Area Compliance: N/A

There is a missing fixing and a bracket has slipped out of place with sharp edges - Repair

The area under the gate has eroded leaving uneven areas, or the concrete foundations exposed, resulting in trip hazards at the entrance/exit to the playground - Reinststate to level with surrounding surfaces

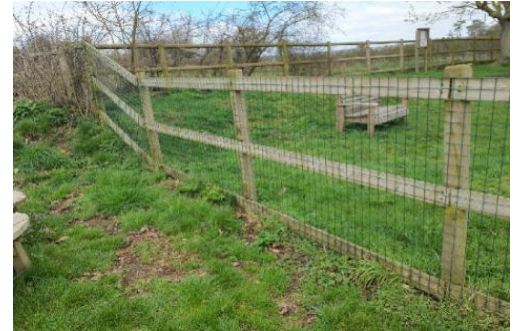
Item: Fence - Timber & Mesh Infill
Manufacturer: Not Identified
Surface Type: Grass
Item Quantity: 1
Equipment Compliance: N/A
Surface Area Compliance: N/A

There is some evidence of rot in the timber - Monitor for any further deterioration and replace as required

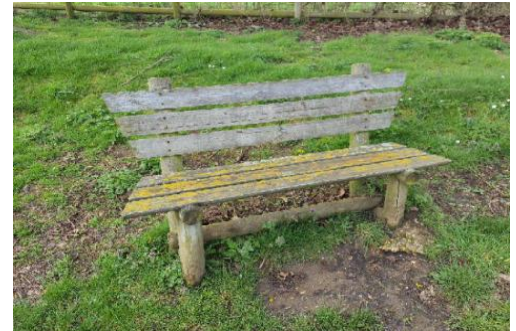
Item: Bench
Manufacturer: Not Identified
Surface Type: Grass
Item Quantity: 2
Equipment Compliance: N/A
Surface Area Compliance: N/A

The foundations are exposed - Reinstall surrounding surfaces to cover the foundations

There is some evidence of rot in the timber - Monitor for any further deterioration and replace as required

There is some strimmer / machinery damage apparent on the posts, this can penetrate the preservative applied to the timber and accelerate the rotting process - Monitor for any deterioration (rot) and replace as required

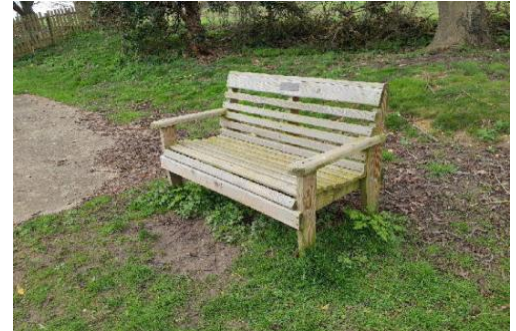
Item: Bench
Manufacturer: Not Identified
Surface Type: Grass
Item Quantity: 3
Equipment Compliance: N/A
Surface Area Compliance: N/A

The area around the item has eroded and may become slippery - Reinstate eroded area

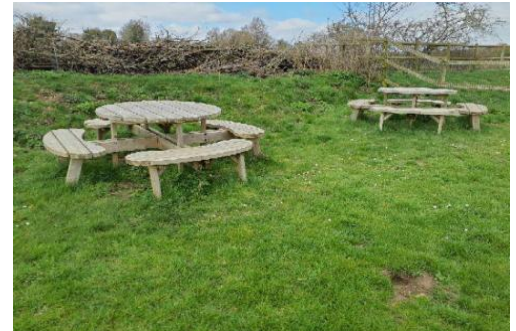
Item: Picnic Table
Manufacturer: Not Identified
Surface Type: Grass
Item Quantity: 2
Equipment Compliance: N/A
Surface Area Compliance: N/A

The bench/es is/are not securely fixed to the surface and there is some possibility of the item/s tipping or rolling over - Secure to the ground

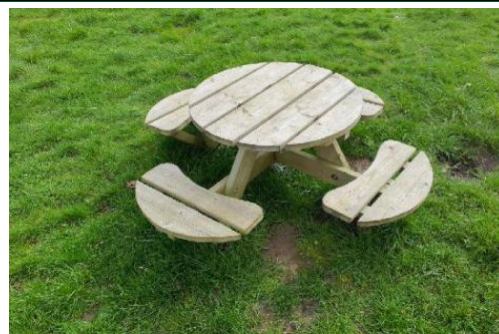
Item: Picnic Table
Manufacturer: Not Identified
Surface Type: Grass
Item Quantity: 1
Equipment Compliance: N/A
Surface Area Compliance: N/A

There are projecting bolt thread(s) present - Remove excess thread length and deburr or provide cap

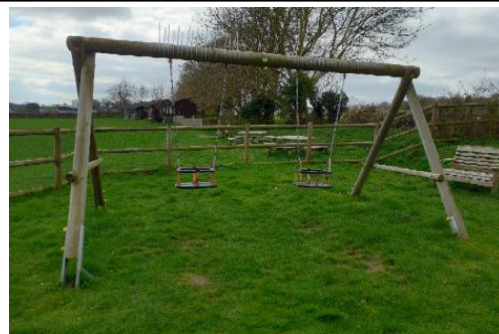
Item: 1 Bay 2 Seat (Cradle)
Manufacturer: Oبرا
Surface Type: Grass Matrix Tiles
Item Quantity: 1
Equipment Compliance: No
Surface Area Compliance: Yes

The chain openings are in excess of the 8.6mm as recommended by BS EN 1176 - Monitor - No remedial work recommended

There is some notable evidence of chain wear - Monitor for any further deterioration and replace when 40% worn

The timber has a number of splits/shakes or air cracks and this may affect the stability or allow water ingress which will accelerate the rotting process - Monitor to ensure the splits do not cross through fixing points of the structure and/or cause any instability

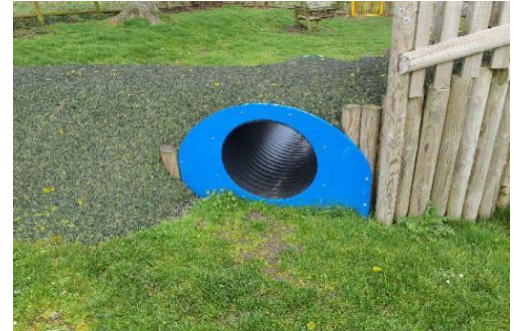
Item: Crawling Tunnel
Manufacturer: Oبرا
Surface Type: Grass Matrix Tiles
Item Quantity: 1
Equipment Compliance: No
Surface Area Compliance: Yes

This design / configuration of tunnel mound is well established and has been successfully included in large quantities of playgrounds throughout the UK. Whilst the design does not fully meet the requirements of BS EN 1176 with regards to falls in excess of 600mm over the edge of the tunnel to the surface below, it has been risk assessed as fit for purpose and no changes are recommended to the design - Monitor - No remedial work recommended

There is some damage to the item - Monitor for any further deterioration and repair as required

There are significant gaps (over 30mm) between the surface and the edging or between the joints in the surface; these are large enough for a small foot to enter - Repair surfacing

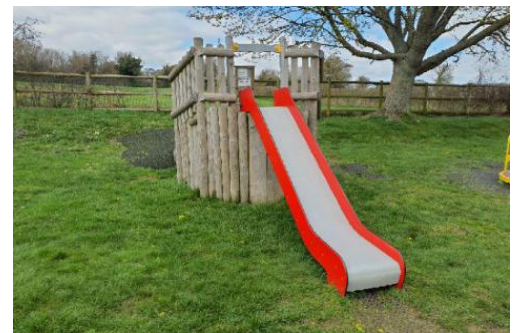
Item: Embankment Slide
Manufacturer: Oبرا
Surface Type: Grass Matrix Tiles
Item Quantity: 1
Equipment Compliance: No
Surface Area Compliance: Yes

There are gaps opening between the surfacing and the edging surround or between the joints in the surfacing - Monitor for any further deterioration and repair as required

The slide start section incline is not in the direction of travel; it should slope towards the direction of the sliding surface to meet the requirements of BS EN 1176 Part 3 - Monitor - No remedial work recommended

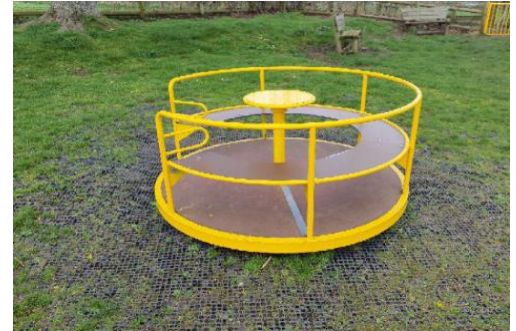
Item: Roundabout
Manufacturer: Oبرا
Surface Type: Grass Matrix Tiles
Item Quantity: 1
Equipment Compliance: No
Surface Area Compliance: Yes

The bearing is showing signs of wear - Monitor for any further deterioration and replace as required

The distance between the underside of the roundabout platform and the playing surface is less than 60mm and contravenes the requirements of BS EN 1176 Part 5 which requires that the distance be maintained between 60mm-110mm for the entire circumference of the roundabout - Monitor - No remedial work recommended

The falling space overlaps the free space between the roundabout and the tunnel mound / embankment slide in contravention of the requirements of BS EN 1176:2017 Part 1 - Monitor - No remedial work recommended

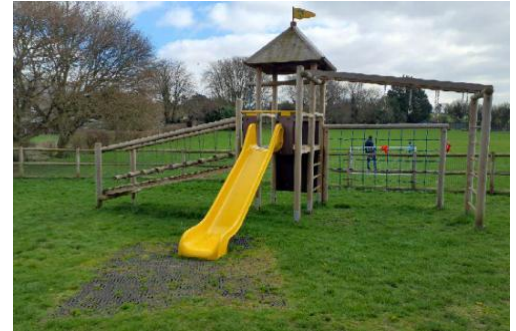
Item: Multi Play (Junior)
Manufacturer: Oبرا
Surface Type: Grass Matrix Tiles
Item Quantity: 1
Equipment Compliance: No
Surface Area Compliance: Yes

The connecting links are in excess of 8.6mm and less than 12mm and fail the requirements of BS EN 1176 Part 1; clause 4.2.13, Chains - Monitor - No remedial work recommended

There is some notable evidence of chain wear - Monitor for any further deterioration and replace when 40% worn

There are openings leading from platforms in excess of 1.0m in height to steep play elements and no hand supports complying with grip or grasp are provided, in contravention of BS EN 1176 Part 1: 4.2.9.4 - Monitor - No remedial work recommended

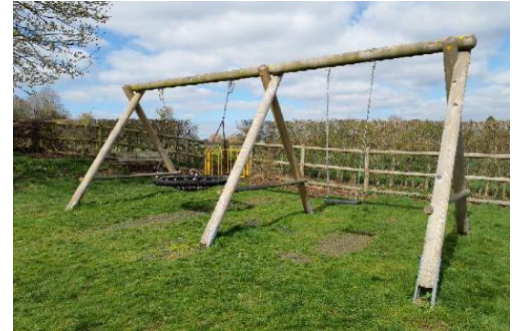
Item: 2 Bay 1 Flat 1 Basket
Manufacturer: Oبرا
Surface Type: Grass Matrix Tiles
Item Quantity: 1
Equipment Compliance: Yes
Surface Area Compliance: Yes

This design of swing joint has been known to fail on the weld connecting the joint to the threaded stud - We would recommend that the joint be dismantled and checked on a regular basis or consulting with manufacturer on whether a Secondary Safety Device can be fitted

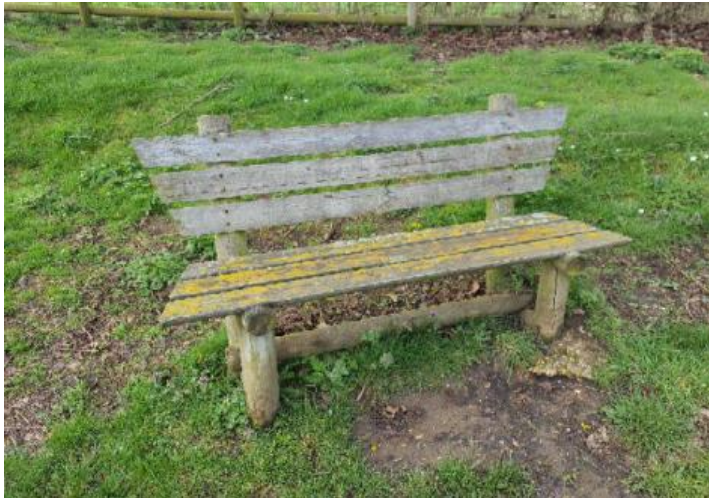
Item: Ancillary Items - Bench
Manufacturer: Not Identified

Finding: The area around the item has eroded and may become slippery

Action: Reinstatate eroded area

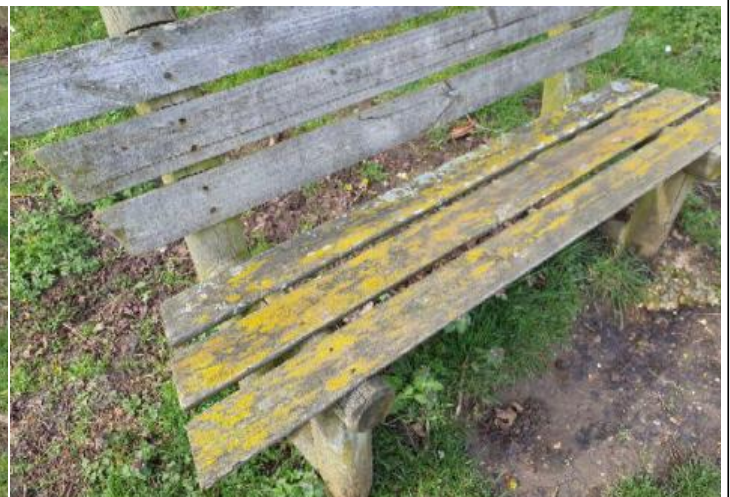
Item: Ancillary Items - Bench
Manufacturer: Not Identified

Finding: There is algae or moss on the surface of the equipment

Action: Clean and treat appropriately

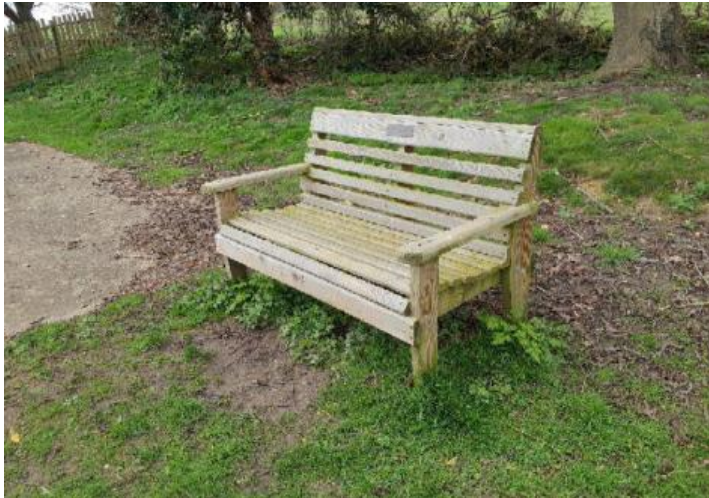
Item: Ancillary Items - Bench
Manufacturer: Not Identified

Finding: The area around the item has eroded and may become slippery

Action: Reinstate eroded area

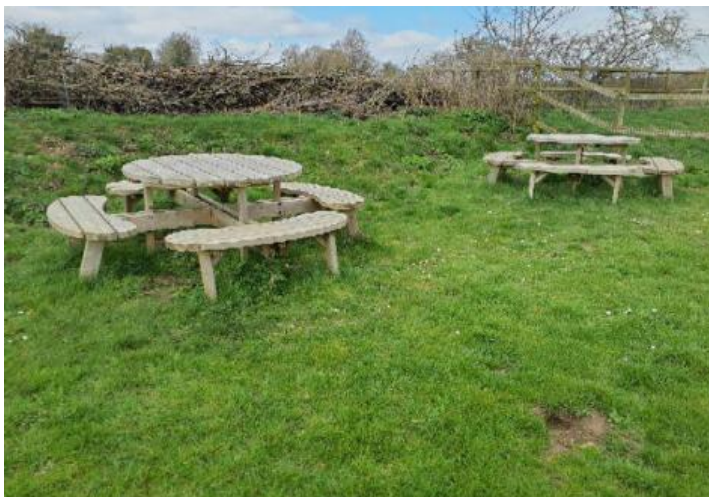
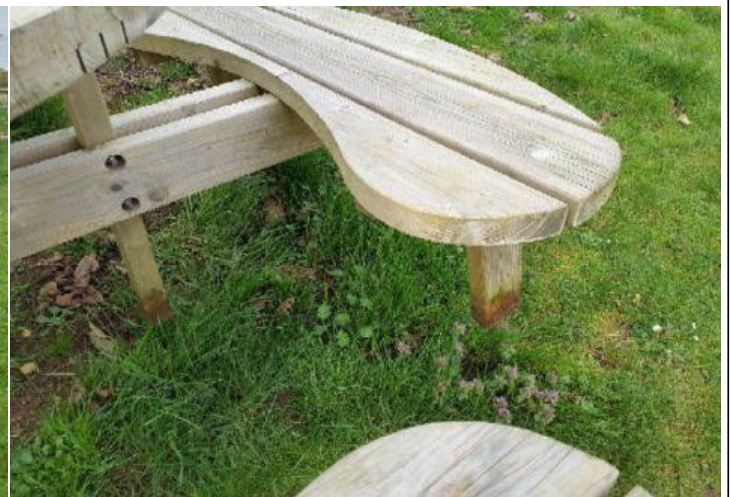
Item: Ancillary Items - Picnic Table
Manufacturer: Not Identified

Finding: The bench/es is/are not securely fixed to the surface and there is some possibility of the item/s tipping or rolling over

Action: Secure to the ground

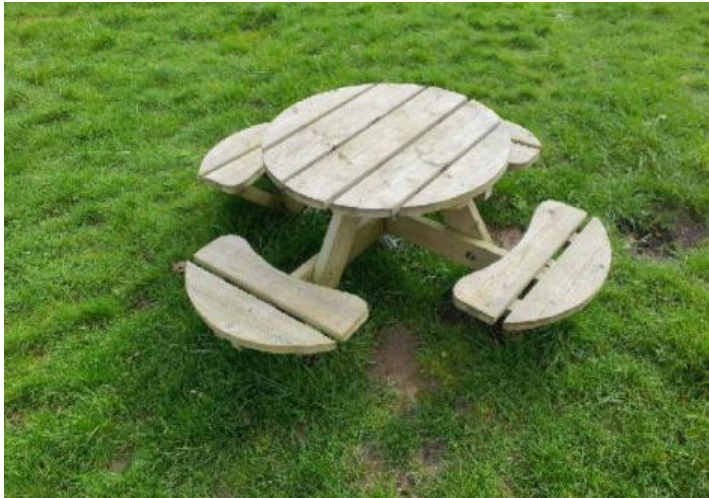
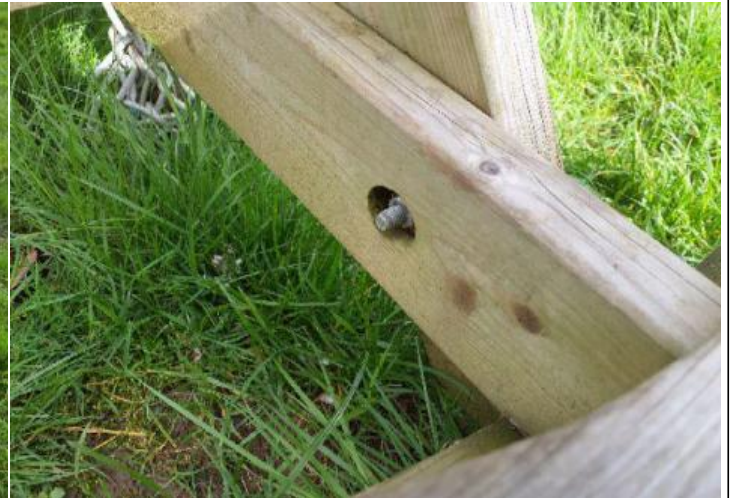
Item: Ancillary Items - Picnic Table
Manufacturer: Not Identified

Finding: There are projecting bolt thread(s) present

Action: Remove excess thread length and deburr or provide cap

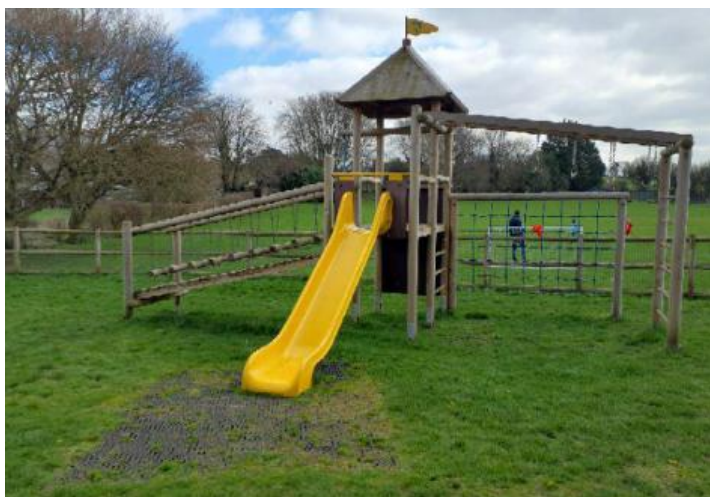
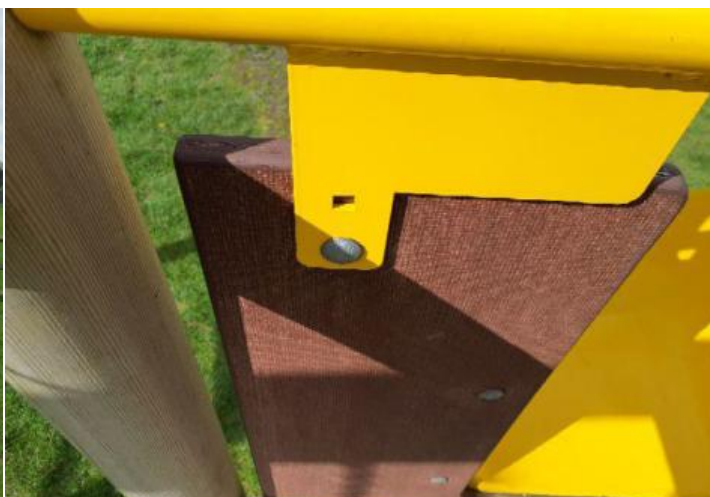
Item: Activity Equipment - Multi Play (Junior)
Manufacturer: Obra

Finding: There are unused fixing holes

Action: Refer to manufacturer
